Asbestos Survey for

Multibase Demonstrations

Marshgate Offices
High Road
London
E20 1AS

Project Number: T2ARG

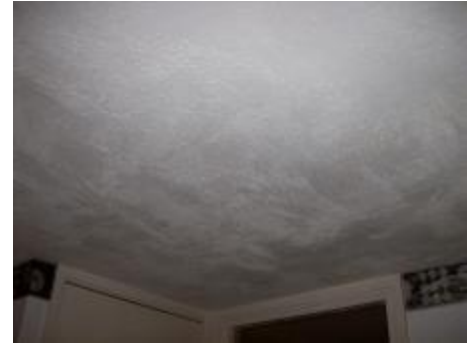
Priority Assessment Algorithm			
Assessment factor	Variable(s) selected	Score for each variable	Overall score
Normal Occupant Activity:			
Main type of activity in area:	Low disturbance	1	average 1
Secondary activities for area:	Low disturbance	1	
Likelihood Of Disturbance:			
Location:	Rooms up to 100 m2	2	average 1
Accessibility:	Occasionally likely to be disturbed	1	
Extent/Amount:	<=10 m2 or <=10 m pipe run	1	
Human Exposure Potential:			
Number of occupants:	>10	3	average 3
Frequency of use of area:	Daily	3	
Average time area is in use:	>6 hours	3	
Maintenance Activity:			
Type of maintenance activity:	Low disturbance	1	average 1
Frequency of maintenance activity	<=1 per year	1

Total Priority Assessment Score:		6
Material Assessment Score (supplied by surveyor):	Very Low Risk	2
Total of Material and Priority Assessment Scores:		8
