# **Asbestos Survey for**

Multibase Demonstrations

Marshgate Offices  
High Road  
London  
E20 1AS

Project Number: T2ARG

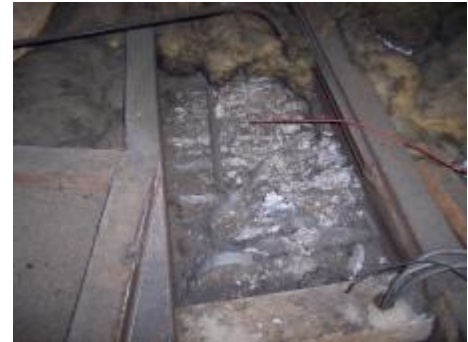
Location ID:	201
Location Ref:	T2ARG/BS01
Product:	Debris
Area:	Not Applicable
Floor:	Roof level
Room:	Roof space
Surveyor Name:	N. Jones
Drawing Ref:	T2ARG/DRW/01
Asbestos ?	Yes
Date:	15 October 2008

Sample Date	Location Ref	Location ID	Drawing Reference	Floor	Room	Asbestos Type	Product Name	Material Risk Score	Material Risk Band	Priority Risk Score	Comments	Action	Survey Type
15/10/07	T2ARG/BS01	201	T2ARG/DR W/01	Roof level	Roof space	Amosite & Chrysotile	Debris	10	High Risk	4	Remove debris and carry out environmental clean of roof space under fully controlled conditions	Action required see comments	T 2

Total Priority Assessment Score:		4
Material Assessment Score (supplied by surveyor):	<b>High Risk</b>	10
Total of Material and Priority Assessment Scores:		14

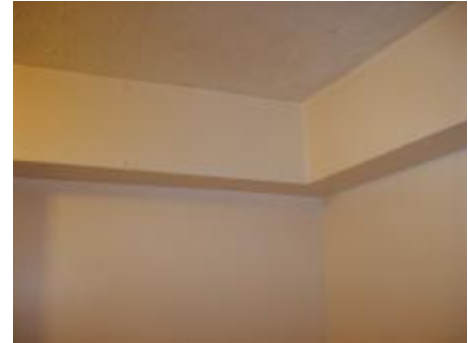
Total Priority Assessment Score:	4
Material Assessment Score (supplied by surveyor):	Low Risk 5
Total of Material and Priority Assessment Scores:	9

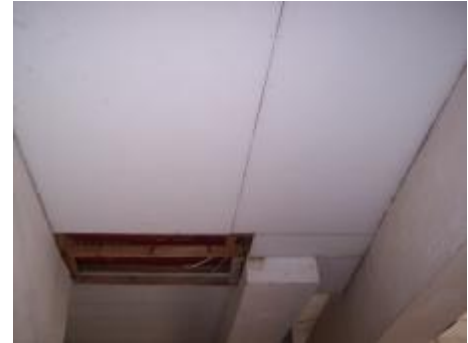
Total Priority Assessment Score:	6
Material Assessment Score (supplied by surveyor):	Very Low Risk 3
Total of Material and Priority Assessment Scores:	9

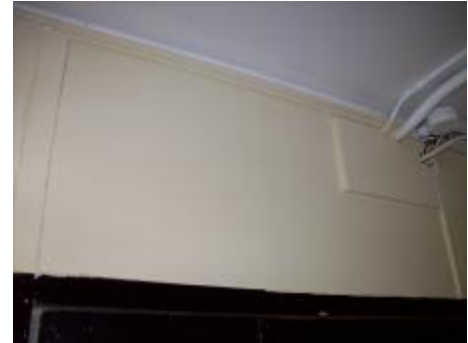
Total Priority Assessment Score:	3
Material Assessment Score (supplied by surveyor):	Medium Risk 7
Total of Material and Priority Assessment Scores:	10

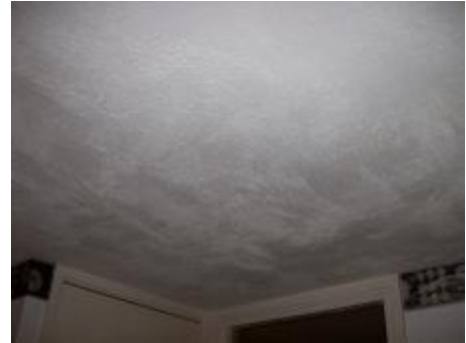
Total Priority Assessment Score:		6
Material Assessment Score (supplied by surveyor):	Very Low Risk	2
Total of Material and Priority Assessment Scores:		8
